# NONPOINT SOURCE PROGRAM SUCCESS STORY

### Pasture Grazing Best Management Practices Result in Pathogen (Fecal Coliform) Delisting

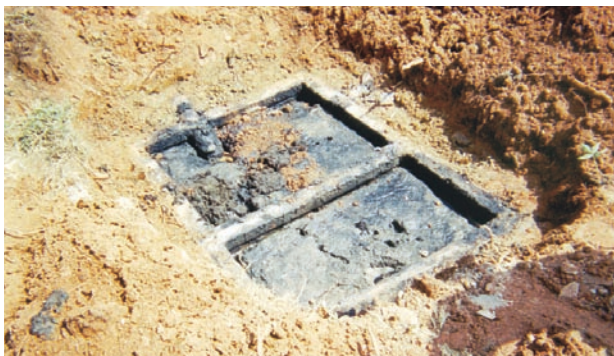
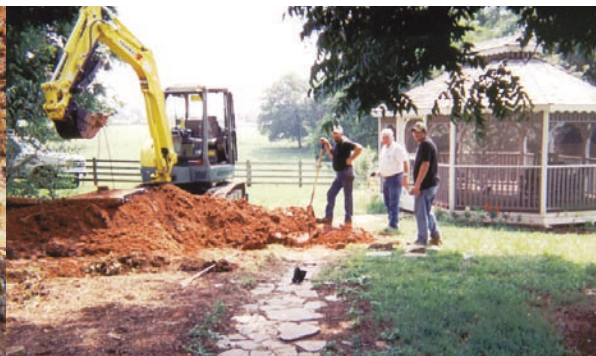
This septic tank was completely filled with solids. Cooperators removed the solids and replaced the tank.

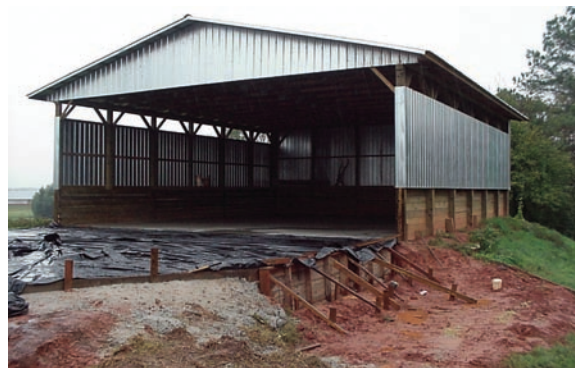
Waste stacking sheds, like this one, reduce the amount of fecal coliform that washes away after a rain event.

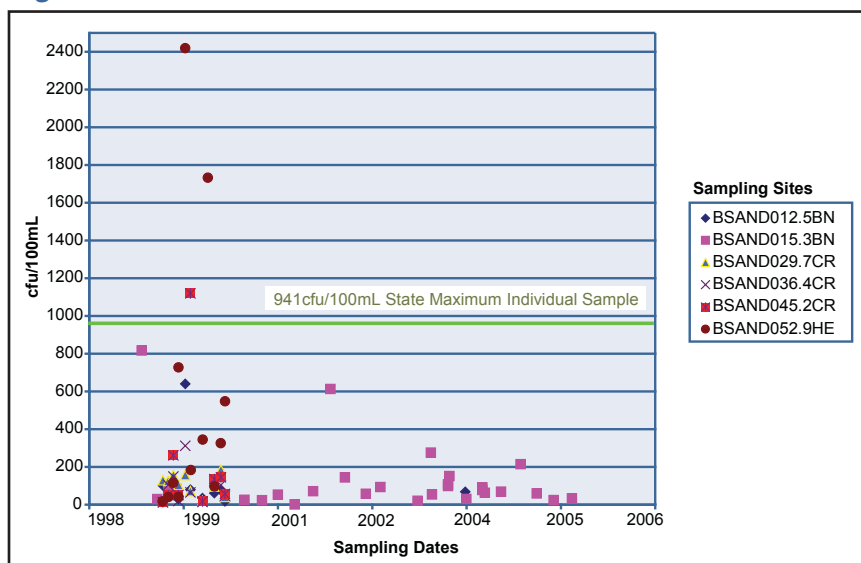
**Figure 1. *E. coli* values from 1998 to 2006.**

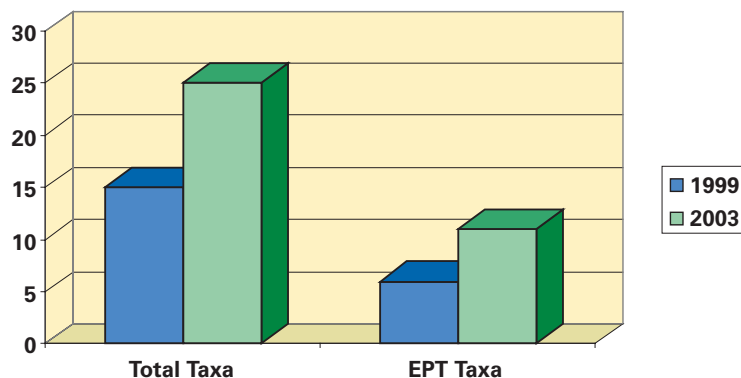
Number of families in the pollution-sensitive group EPT found at Blue Spring Creek in Coffee County between 1999 and 2003.

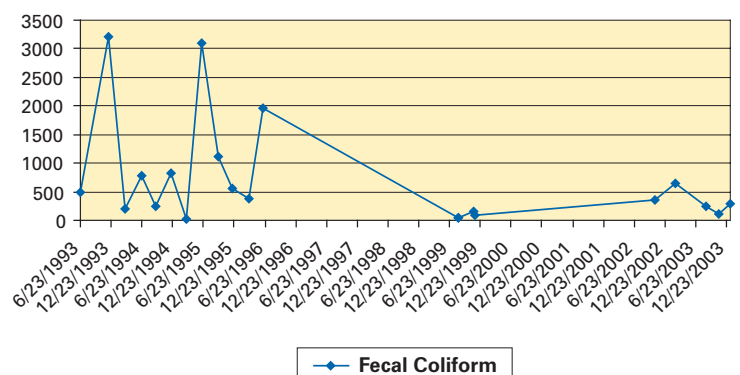
Number of fecal coliform colonies per 100 mL at Cane Creek River Mile 1.5 in McMinn County 1993–2004. Data collected by Water Pollution Control, Tennessee Department of Environmental Conservation.

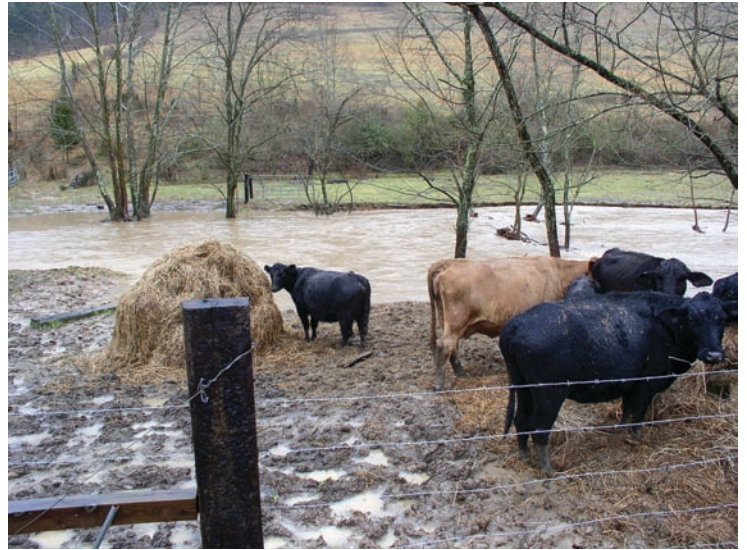
Before the project, high flows during storm events caused increased erosion.

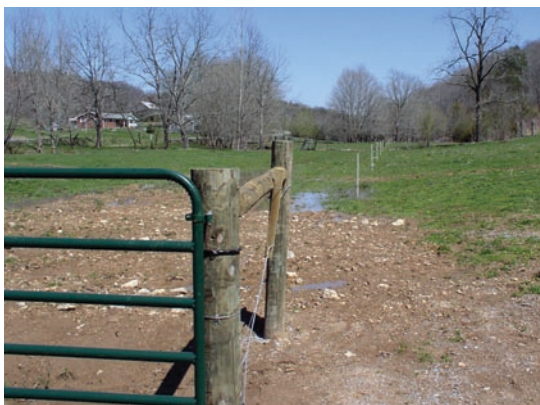
Installed fencing with stream buffer on left.

The BMPs installed included (1) pasture seeding and riparian zone planting along Hinds Creek and tributaries; (2) stabilization of heavy-use areas using gravel and geotextile fabric; (3) installation of alternative watering facilities, such as tanks, troughs, and ponds fed by pipelines to keep livestock out of streams; and (4) alternative access roads to help combat further erosion.

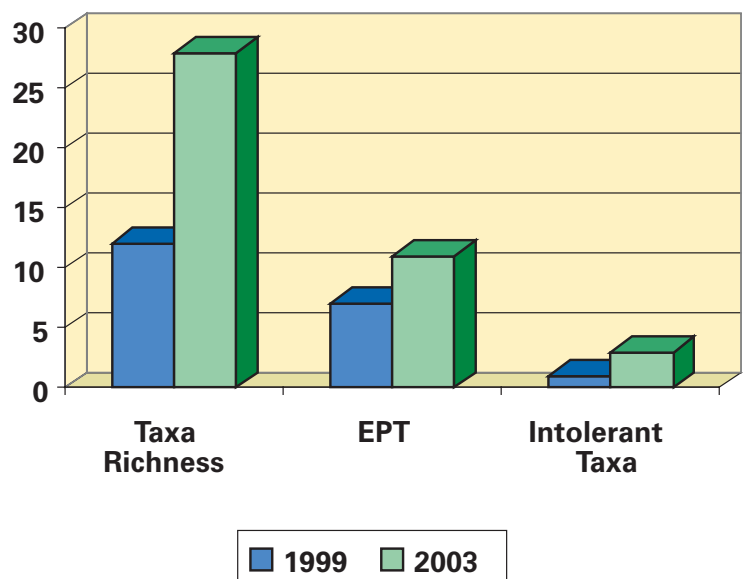
Macroinvertebrate taxa groups found in 1999 and 2003 from Little Shoal Creek in Lawrence County.

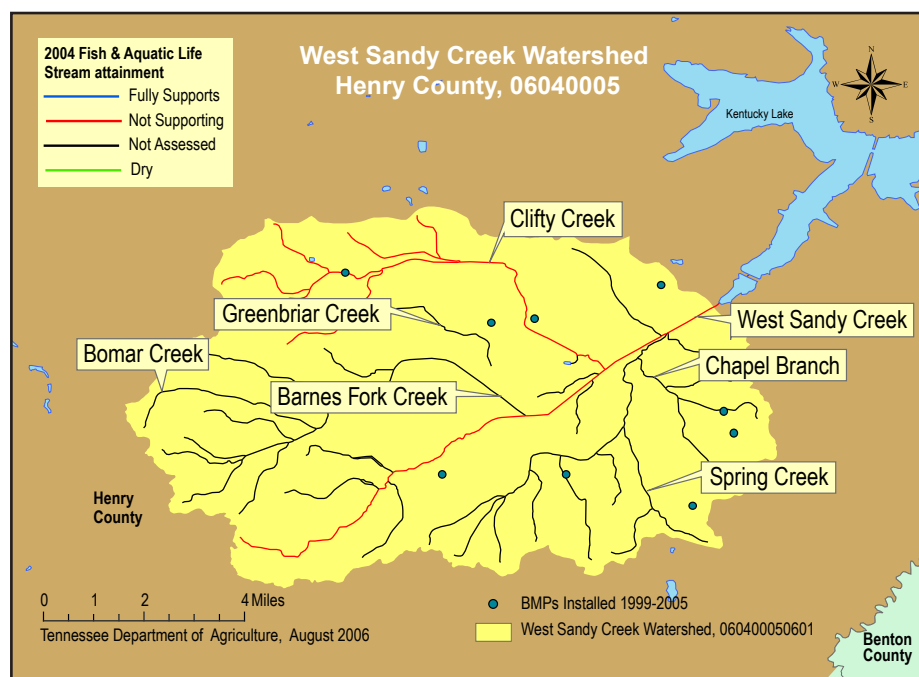
Figure 1. Location of BMPs installed along West Sandy Creek, TN.

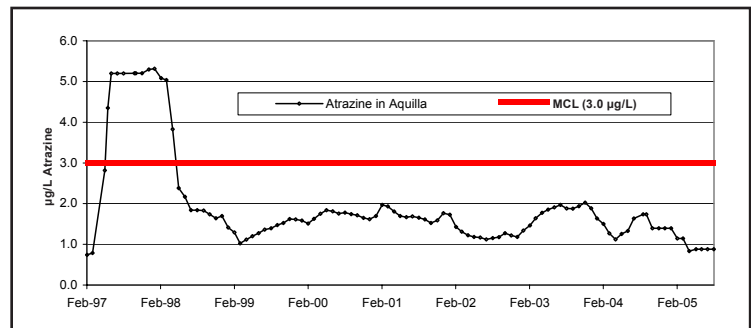
Atrazine concentrations in Aquilla Reservoir. Data represent running annual averages. Concentrations have steadily remained below the maximum contaminant level (MCL) since 1998. With the reservoir meeting the MCL requirement for more than 2 consecutive years, Texas has recommended that it be removed from the state's 303(d) list.

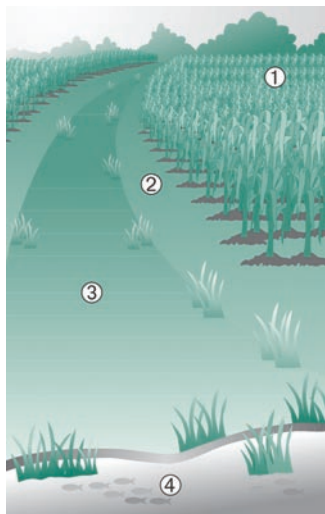
Sample best management practices used to reduce atrazine loads. A field of corn (1) is cultivated. Atrazine is tilled into the soil, rather than simply applied on top of the ground. Farmers may install filter strips (2) between the field and an adjacent creek (4). A grassed waterway (3) may also be used to direct runoff to the creek while filtering out pollutants at the same time.

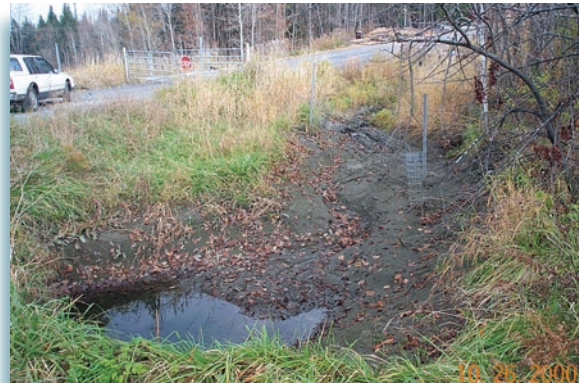
Ditch near Adams Brook prior to being lined with rock. Rock lining reduced sedimentation into Adams Brook.

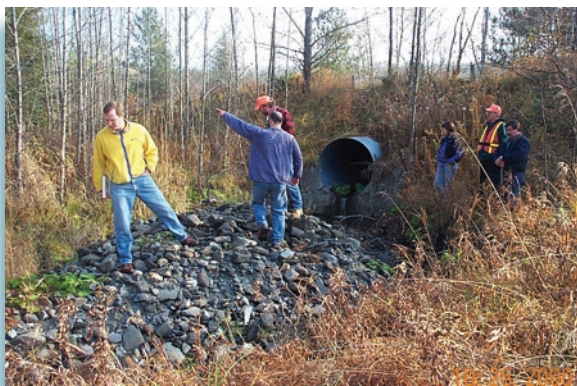
Geomorphic instability and an unauthorized culvert (upstream of the location in this photo) caused heavy erosion and the dumping of rock piles at the culvert shown here. Removing the unauthorized culvert helped to address the instability and reduce the water quality impacts on Adams Brook.

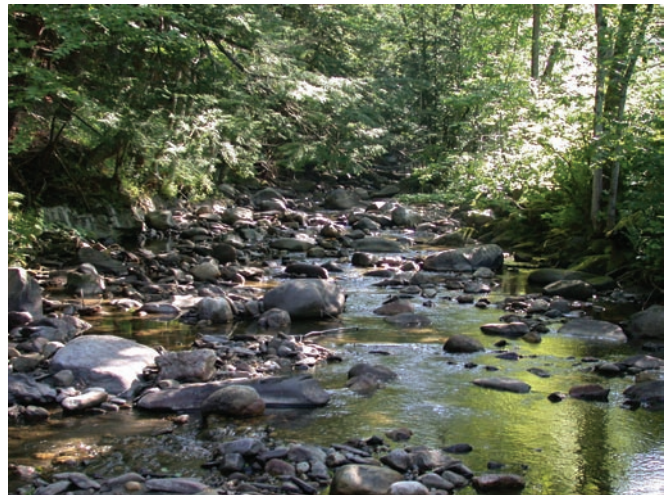
Stream embeddedness—the extent to which sediment filled in gaps around rocks and cobbles in the Chase and Slide Brook streambeds—was 50–75 percent before the restoration effort. Embeddedness declined to 25–50 percent following restoration, representing significant habitat improvement.

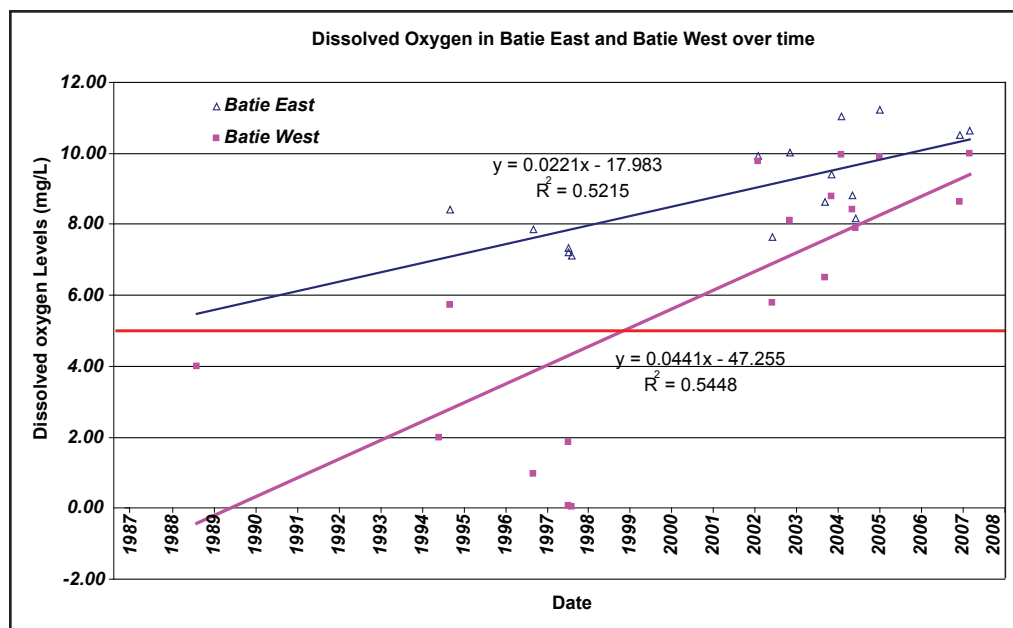
**Figure 1. Regression of dissolved oxygen 1998-2007.**

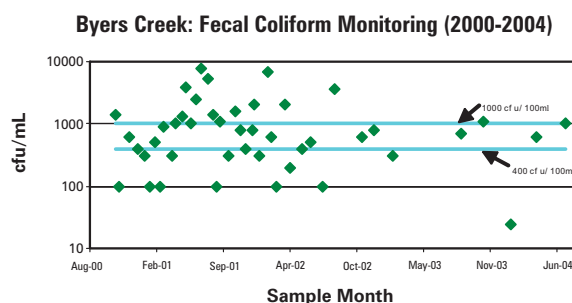
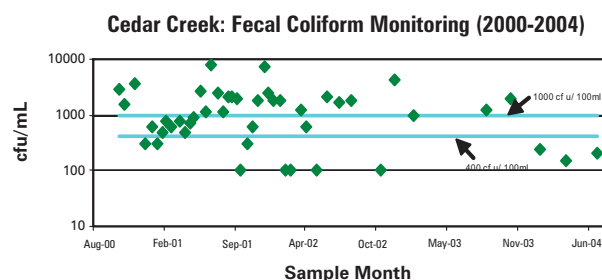
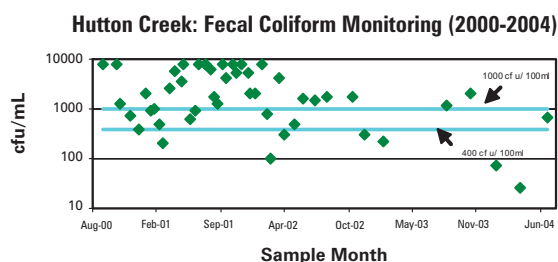
**Figure 1**

The Virginia Department of Environmental Quality (DEQ) monitors the impaired streams through the agency's ambient monitoring program. Since the beginning of implementation efforts in 2001, high fecal coliform values have decreased in the Byers, Cedar, and Hutton Creek watersheds (Figure 1). Bacteria water quality violations of the 1,000 cfu/100 mL instantaneous standard for fecal coliform

bacteria were reduced by an annual average of 50 percent during the period 2000 to 2004 in Hutton Creek. Ongoing monitoring will be necessary to verify a sustained decrease in fecal coliform concentrations and general overall improvement in water quality.

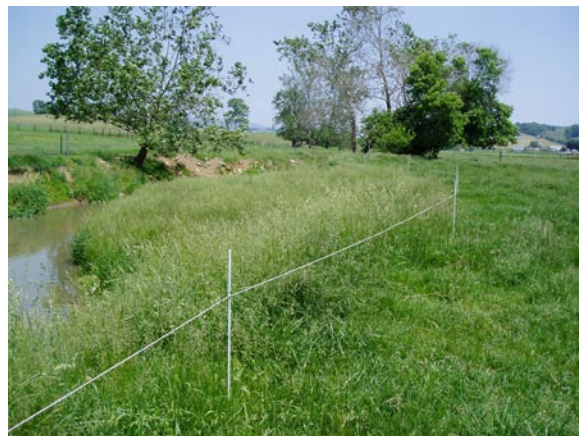
Voluntary stream exclusion fencing keeps livestock away from Muddy Creek.

the agricultural community developed systems to manage waste, reduce soil compaction, and minimize runoff from livestock resting areas. Project funding supported the installation of 10 miles of livestock exclusion fencing and 1,200 acres of cover crops. Funding also helped farmers to implement nutrient management plans that called for applying fertilizer on cornfields only when the crop needed it and could use it most efficiently. Finally, project funding enabled landowners to pump out 30 septic tanks, repair or replace 13 septic systems, and install 5 alternative waste treatment systems.

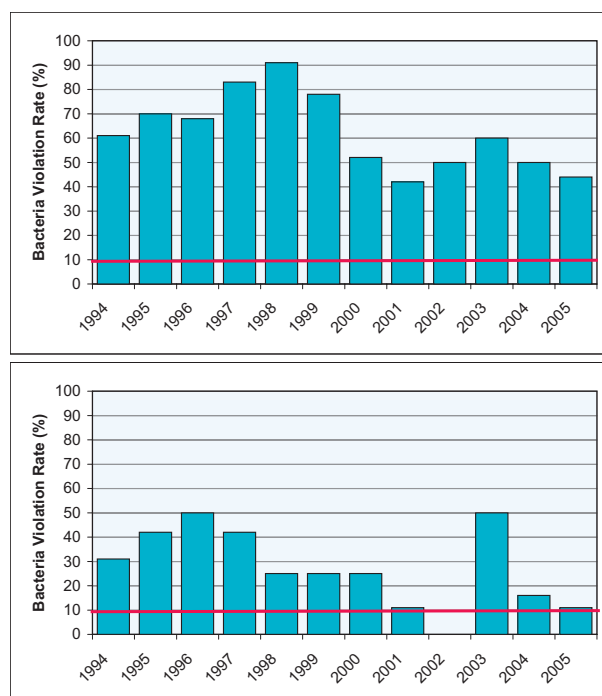
Violation rate of the 1,000 colony-forming units/100 mL instantaneous standard for fecal coliform bacteria in Muddy Creek (top) and the Lower Dry River (bottom). To be delisted for impairments caused by fecal coliform bacteria, a waterbody may not have a bacteria violation rate greater than 10 percent (represented by the red line).

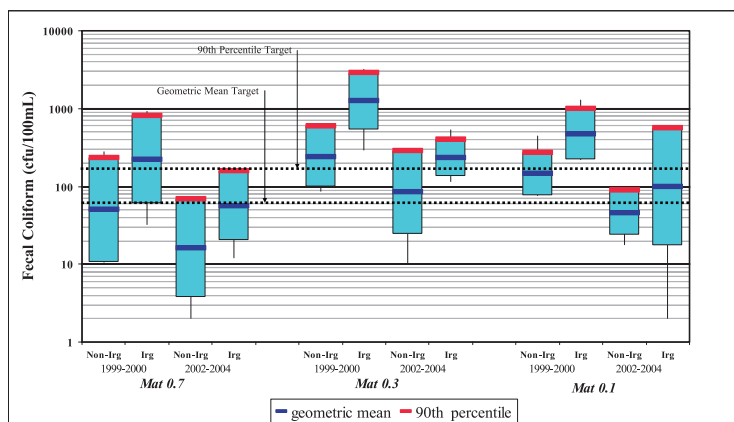
Lower Matriotti Creek irrigation and non-irrigation season fecal coliform data for the TMDL and most recent 2 years of data.

There is an ongoing effort to pipe many of the irrigation ditches and eliminate tailwaters in the extensive irrigation network in the watershed. Ditches selected for piping were those deemed high-priority by the Clallam Conservation District based on bacterial monitoring results. In addition to improving water quality, these activities helped to achieve important water conservation goals as well.

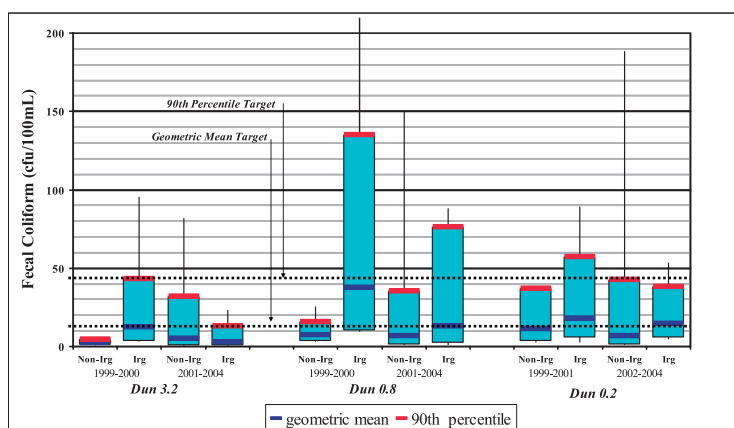
Dungeness River irrigation and non-irrigation season fecal coliform data for the TMDL and the most recent 2-year period of data (2002–2004).

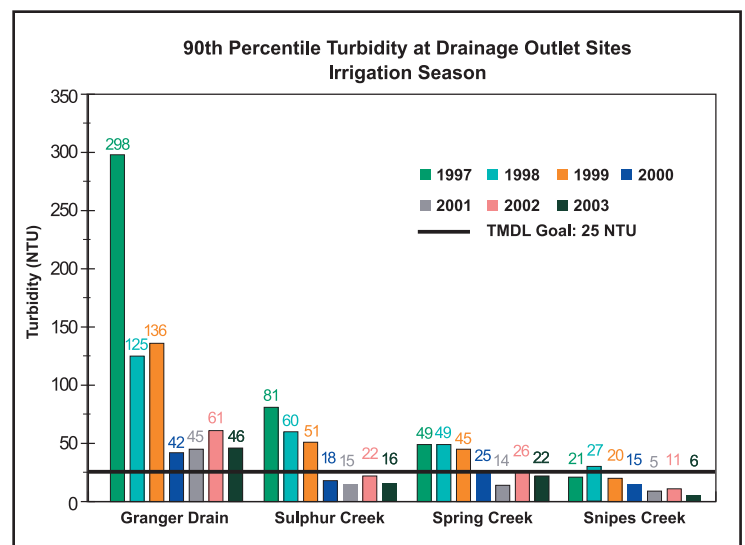
Graph represents decreases in turbidity at the four major tributaries in the lower Yakima, with a goal of 25 NTU 90 percent of the time.

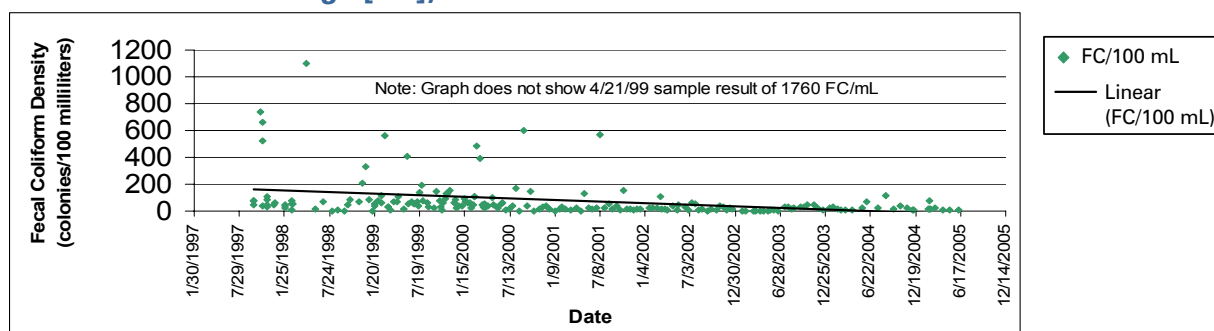
**Fecal Coliform Densities in the Nooksack River at the Marine Drive Bridge (Sample Station Maritetta Bridge [M1])**

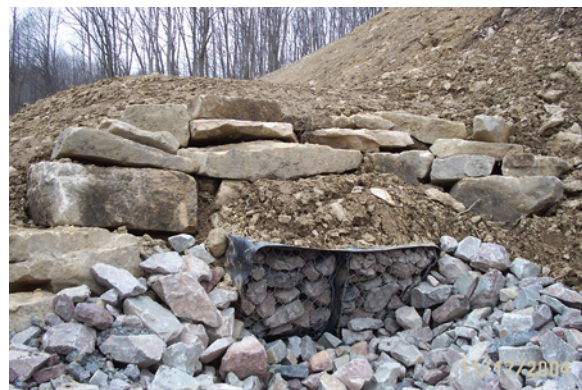
Trap design using stone in wire mesh baskets to help aerate the water. It then flows through the short open limestone channel into the settling basin.

Cheat River. Open limestone channels, limestone/steel stag check dams, and vertical flow ponds were installed to neutralize acidity and allow metals to settle out of the water before entering the creeks.

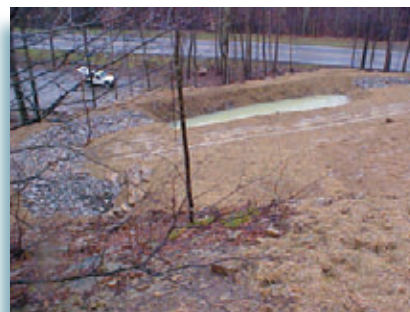
View of outlet from anoxic limestone drain through the short open limestone channel and into the settling basin.

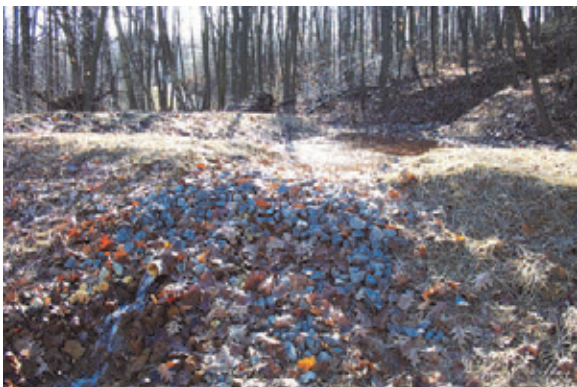
Limestone leach bed and outflow soon after completion in fall 2003.

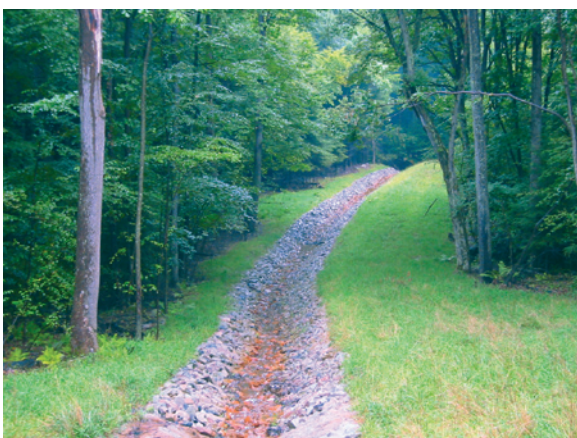
Open limestone channel running through the woods with coloration starting to show iron precipitate.

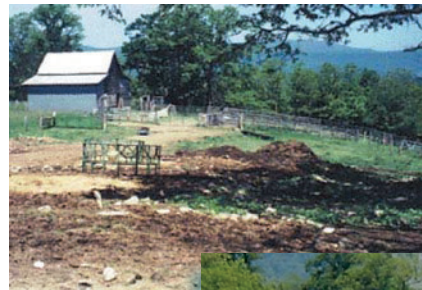
#### Before

An animal feedlot that allowed runoff of contaminants into the nearby stream.

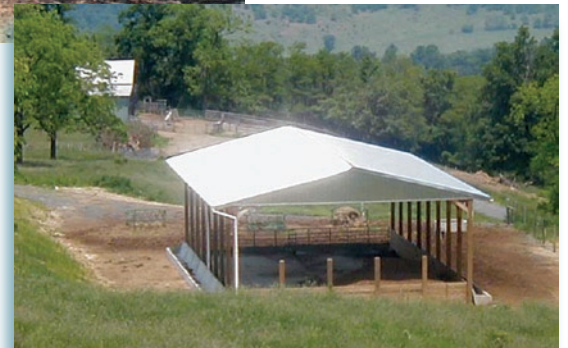
**After**  
A new animal feedlot that is covered and has a concrete pad and adequate buffer has been installed.

Since then, a range of BMPs have been established to help control runoff from feedlots and eliminate or reduce cattle access to the streams. To keep cattle out of the streams, farmers installed streambank fencing and developed alternative livestock watering facilities. Farmers also constructed roofs over feeding areas, as well as new animal waste storage facilities to provide shelter and prevent runoff. Other efforts focused on streambank restoration through stabilizing critically eroding areas and

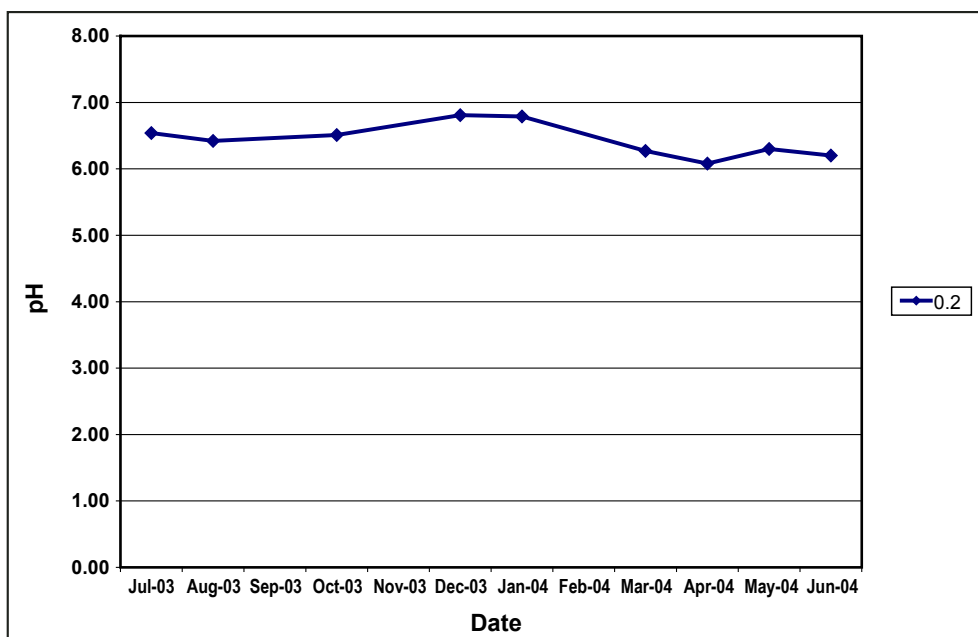
pH data from WV for Sugar Creek mile point 0.2.

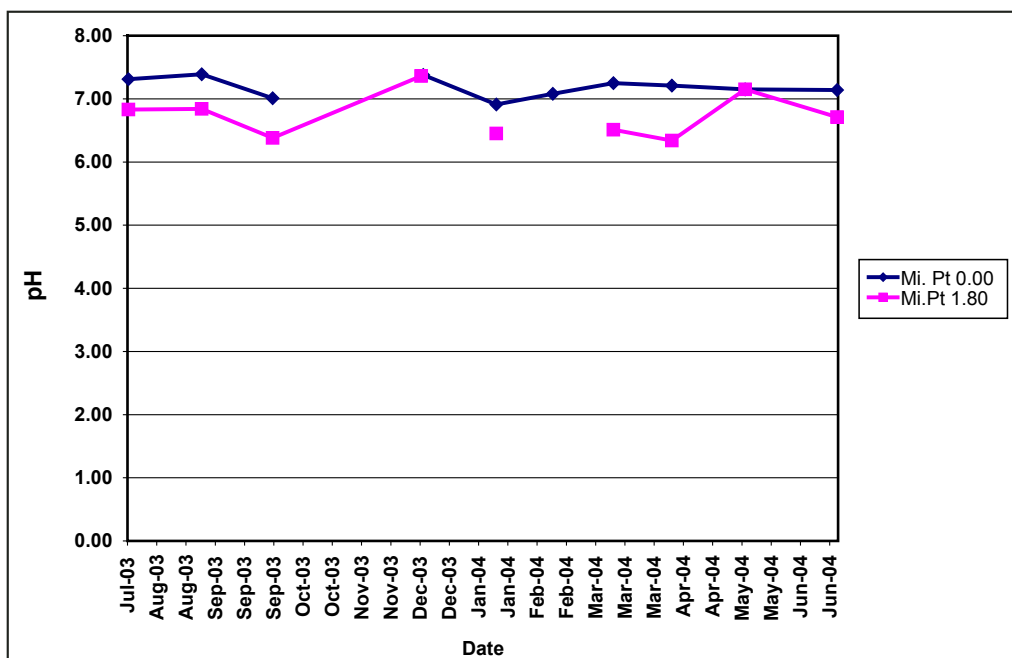
pH data from WV for Dogway Fork mile points 0.0 and 1.80.
